Smoke and Dye-Water Observation Summary

Western Run Pilot Project - Baltimore Maryland

INSPECTION REPORT

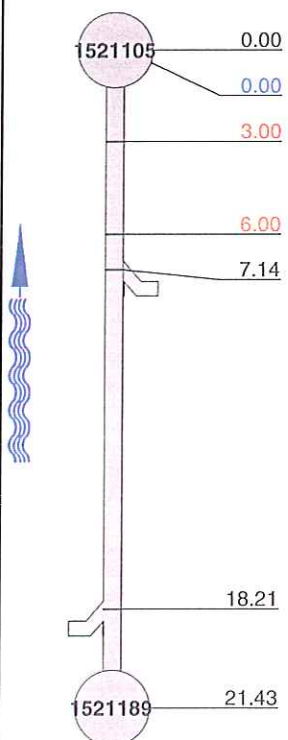
0.00	inspection begins at downstream manhole, 1521105	0	00:00:00	
	0.00	Infiltration Seeping at joint at 04 o'clock	2	00:00:29	2a
	3.00	Infiltration Running at joint from 04 to 08 o'clock	3	00:02:07	3a, b
	6.00	Infiltration Running at joint at 08 o'clock	3	00:02:31	
	7.14	service connection capped at 09 o'clock	0	00:02:50	
	18.21	service connection capped at 03 o'clock	0	00:04:05	
	21.43	inspection ends, NO MORE DYE TEST LEAKS SEEN.	0	00:04:27	7a
